Contract #: 04-0120F4Cty: SF/ALA Rte: 80 PM: 13.2/13.9File #: 69.28**WELDING INSPECTION REPORT****Resident Engineer:**Pursell, Gary**Address:** 333 Burma Road**City:** Oakland, CA 94607**Report No:** WIR-000916**Date Inspected:** 04-Nov-2007**Project Name:** SAS Superstructure**OSM Arrival Time:** 630**Prime Contractor:** American Bridge/Fluor Enterprises, a JV**OSM Departure Time:** 1530**Contractor:** Zhenhua Port Machinery Company, Ltd (ZPMC), Changxing Island **Location:** Shanghai, China**CWI Name:** Xu Lefeng**CWI Present:** Yes No**Inspected CWI report:** Yes No N/A**Rod Oven in Use:** Yes No N/A**Electrode to specification:** Yes No N/A**Weld Procedures Followed:** Yes No N/A**Qualified Welders:** Yes No N/A**Verified Joint Fit-up:** Yes No N/A**Approved Drawings:** Yes No N/A**Approved WPS:** Yes No N/A**Delayed / Cancelled:** Yes No N/A**Bridge No:** 34-0006**Component:** Tower Mock-up and OBG**Summary of Items Observed:**

CALTRANS Quality Assurance (QA) Inspector, Alfredo Acuna was present for the fabrication scheduled for this project at the ZPMC facility in Shanghai, China for the San Francisco Oakland Bay Self Anchored Suspension Bridge.

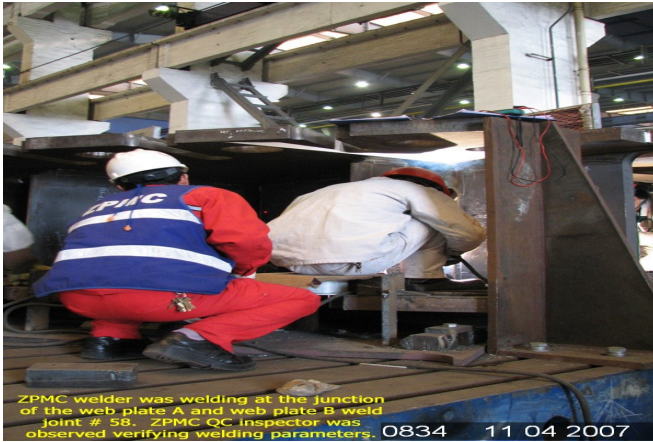
1	89 Mock-up Assembly- MUB1		
---	---------------------------	--	--

Welder Gou Den Yun was observed by the QA Inspector performing welding operations at the junction of web plate A to web plate B connection, joint # 55. Base metal was designated as A-709M HPS 485W. ZPMC was using the shielded arc welding (SMAW) process in the horizontal (2G) position with the 4 mm diameter electrode designated as E-9018M -H4R, brand name Excalibur. The photograph below shows ZPMC performing welding operation at the diaphragm for the 89M Mock-up.

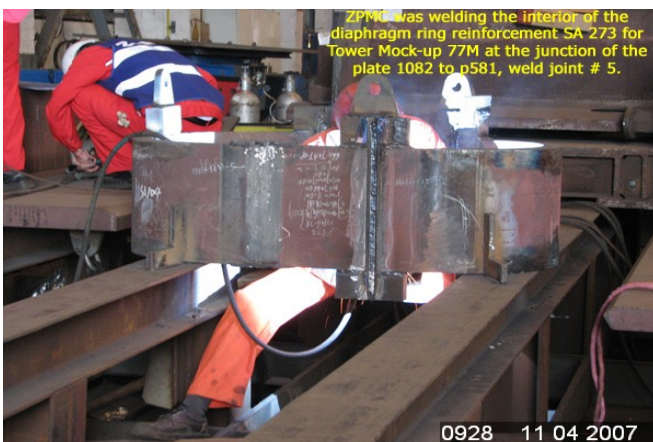
2 Welding the Flange Reinforcement ring SA-273 Tower Mock-up 77 M

The QA inspector observed welder Wang Bing performing welding operation with flux cored arc welding (FCAW) process at the flange reinforcement ring SA-273 splice weld joint # 5. The QA inspector performed random verifications of the welding parameters. The QA inspector found that welds appeared to be in accordance with the contract documents.

The photograph below shows Mr. Wang Bing performing welding operations.

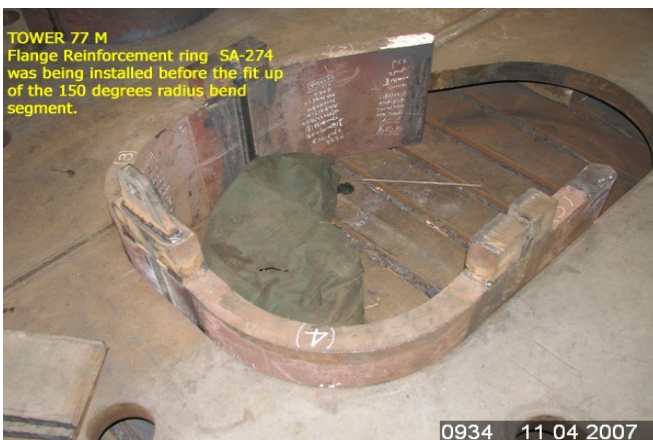
3 Tower Mock-up 77 M Flange reinforcement ring SA-274

ZPMC positioned a portion of the flange reinforcement ring SA-274 at the bottom side of the diaphragm. ZPMC was checking the gaps between the flange and the diaphragm. See photograph below.

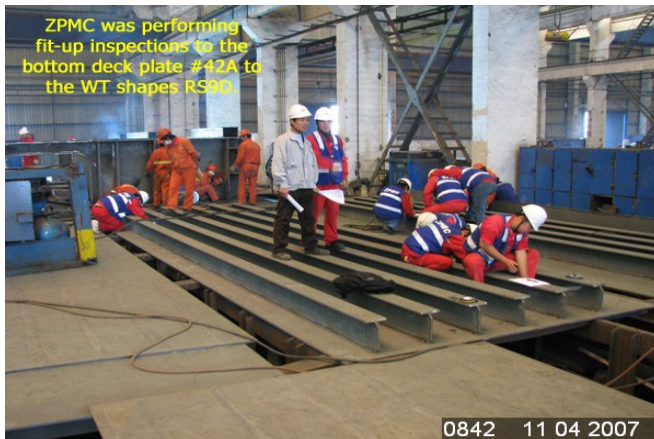
4 OBG Bottom Plate

The QA inspector observed ZPMC performing fit-up operations at the bottom plate assembly panel 42A, BP12 at the junction of the Tee open ribs to the bottom plate. The QA inspector performed random dimensional verifications for the panel 42A, BP12. The QA inspector found that the dimensions appears to be in compliance with ZPMC shop drawings. The QA inspector had a conversation with ZPMC QA representative Fu Yu Hong. The QA asked Mr. Fu about the shrinkage allowance. Mr. Fu relayed that ZPMC was using shrinkage allowance of 0.5 mm between every transverse dimension and longitudinal the total length plus length/2000 (welding shrinkage allowance). See photograph below.

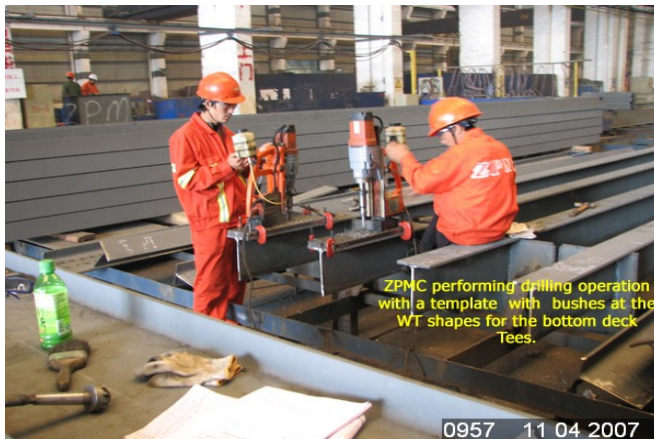
5 OBG Bottom plate Tees Drilling operations

The QA inspector observed ZPMC representatives performing drilling operations at the RS9C WT21x57. The QA inspector observed that ZPMC was using template with hardened bushings. See photograph below.
